El Portal Fire – Sediment/Debris Runoff Mitigation

Scoping Trip Report

September 25, 2014

Yamabe & Horn Engineering, Inc.

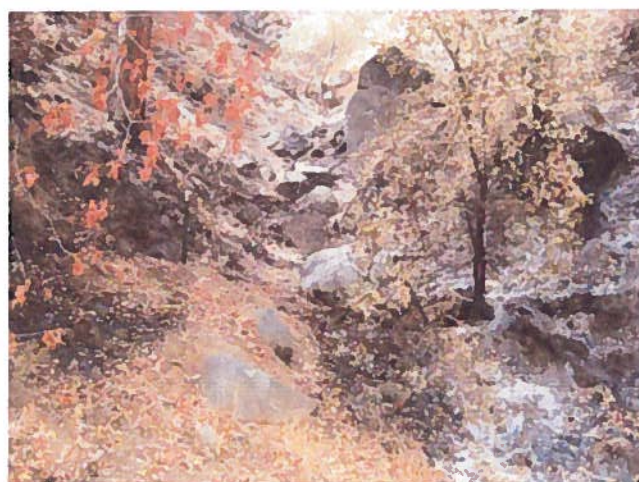
At the time of the site visit, the native terrain consisted of oak trees, pine trees, manzanita brush and native grasses including poison oak. Most areas immediately surrounding the structures were landscaped and maintained. The southern limit of the El Portal fire was located in the El Portal community. Post-fire conditions included charred oak leaves, ashen groundcover, and burned brush and trees to varying degrees. The notable conditions observed within the fire limits were the absence of ground cover and exposed soil.

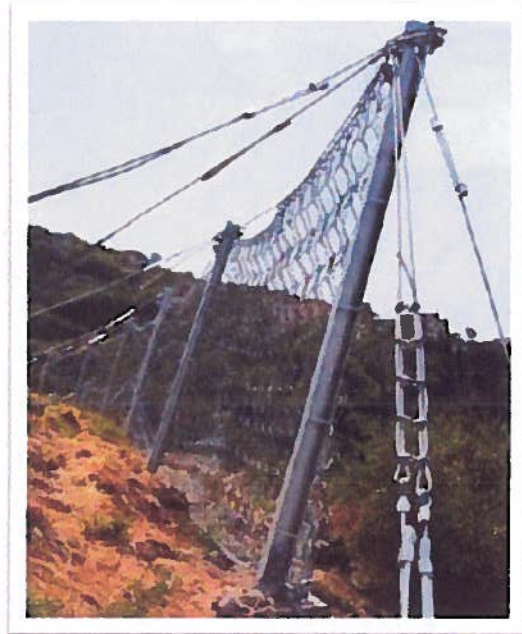
Rockfall barrier fences of variable geometry are typically made of an engineered system of structural posts, cables and double twist wire mesh layer. This mitigation would be effective against the threat of large debris flows and reduce the threat of damage to the downstream structure and owner. The construction method could utilize piles and cable supports that could be installed without the requirement of large construction equipment.

Any number of fences could be installed at intervals up the drainage channel to further reduce the risk of large debris flows. The California Department of Transportation (Caltrans) has used this mitigation method along transportation routes with direct threat of falling rocks. The rockfall system would need to be engineered for a specific range of energy.
